**U.S. COAST GUARD
MARINE SAFETY OFFICE PORTLAND, MAINE**

SAFETY ALERT

Collision Avoidance Advisory

No. 96-07
9/27/96
Photo USCG

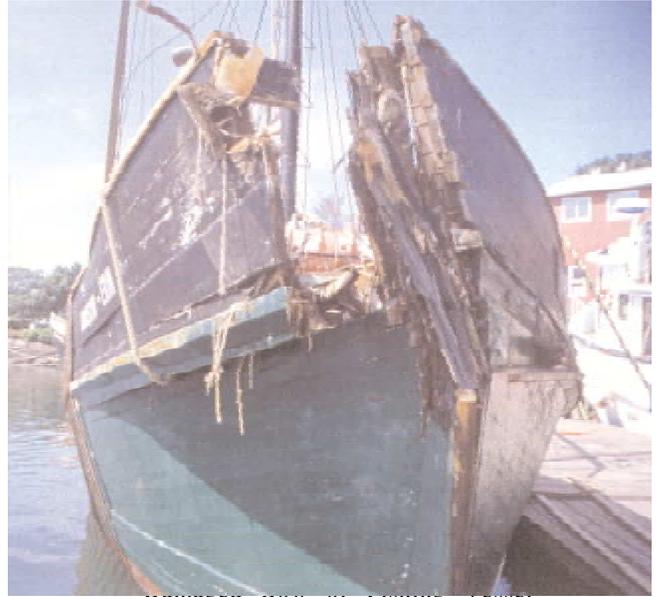
A 60' eastern rigged trawler and a 770' tanker collided in the Gulf of Maine on Sept. 5, 1996. The trawler suffered heavy damage in the incident. Only evasive action taken by the tanker at the last minute prevented the loss of the trawler and possibly the lives of the two fishermen involved in this incident.

Commercial fishermen can significantly reduce the risk of collision with large vessels by ensuring that their vessels provide very strong and continuous radar signatures at very long ranges. Operators of vessels of wood and fiberglass construction should be especially concerned about their long range radar signatures.

The most reliable way to ensure strong radar signatures is to ensure flat metal surfaces are provided well above the waterline from all directions. The addition of radar reflectors at mastheads or fitted to metal poles, similar to high flyers used to mark offshore gear, is highly recommended for all vessels of wood or fiberglass construction.
